NASA Facts

February 2008

Engine Cutoff Sensor System

TROUBLESHOOTING THE ECO SENSOR SYSTEM

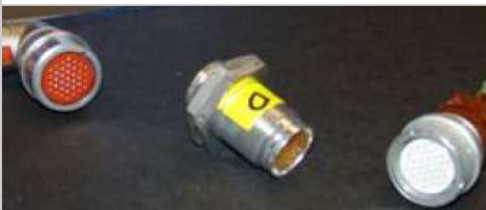
Feed Through Connector
(1.25" dia. x 2.25" length)

All circuit anomalies experienced during testing were able to be repeated as seen during the two launch attempts and tanking test. Open circuits in the part that connects wires from the interior to the exterior of the liquid hydrogen tank, commonly known as the feed through plate, were identified as the culprit that caused false readings during two launch attempts and a tanking test in December 2007.

A modified connector was designed with the pins and sockets soldered together. A similar, but slightly redesigned connector was to be used. Both the original and modified connector configurations were subjected to temperature, pressure and vibration environments identical to those experienced during a shuttle launch. The tests verified the adequacy of the new configuration.

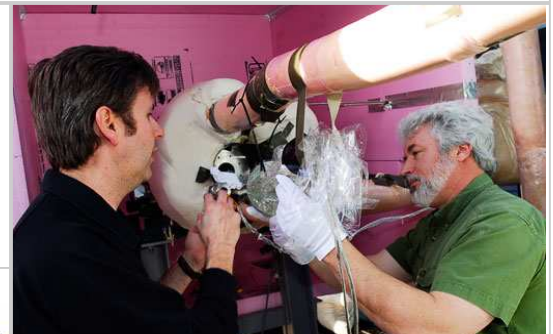
Chad Bryant, ET project manager at Marshall, and Greg Vinyard of Lockheed Martin, prepare to install ET-125's feed through connector in a pressure vessel. The ECO sensor connector is undergoing testing to determine if it was the cause of the false sensor readings.
